# Manhole Inspection Summary

Manhole # S69K\_\_009MH

Insp Date: **9/1/09 3:36 PM**

**Location** Address: **6614 Hudson St.**

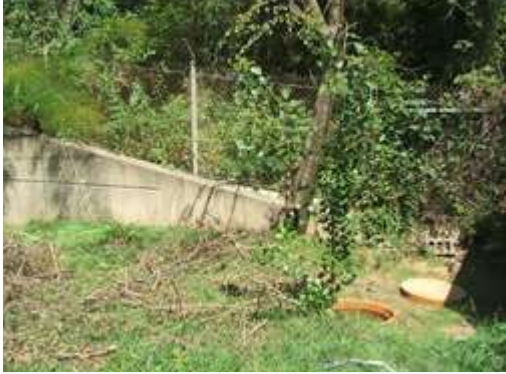
Location View

Comments **NRV2 - LOCATED IN HOMEOWNERS BACK YARD. VERIFIED BY CCTV: 0804, SETUP J0235, VIDEO DU-J0235.**
